## **CHARTLET FOR THE DEBEN ENTRANCE 2020** ***PLEASE READ AND TAKE NOTE -***

2020 VERSION 2

# RIVER DEBEN ENTRANCE

Based on Trinity House survey March 2019

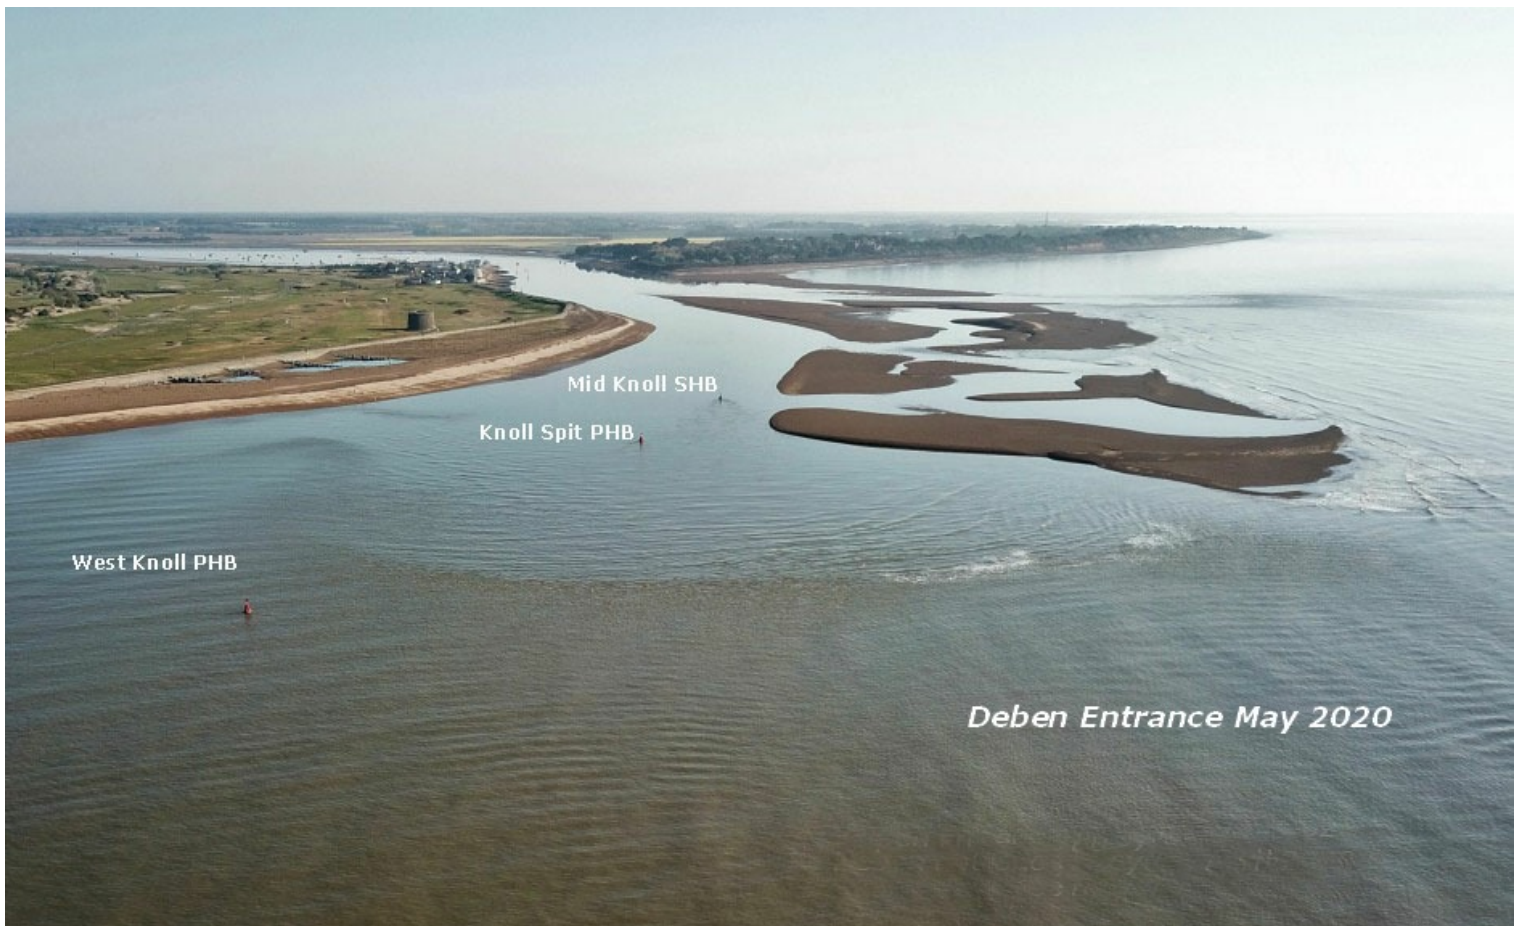
Also show below is an aerial photo of the entrance buoyage.

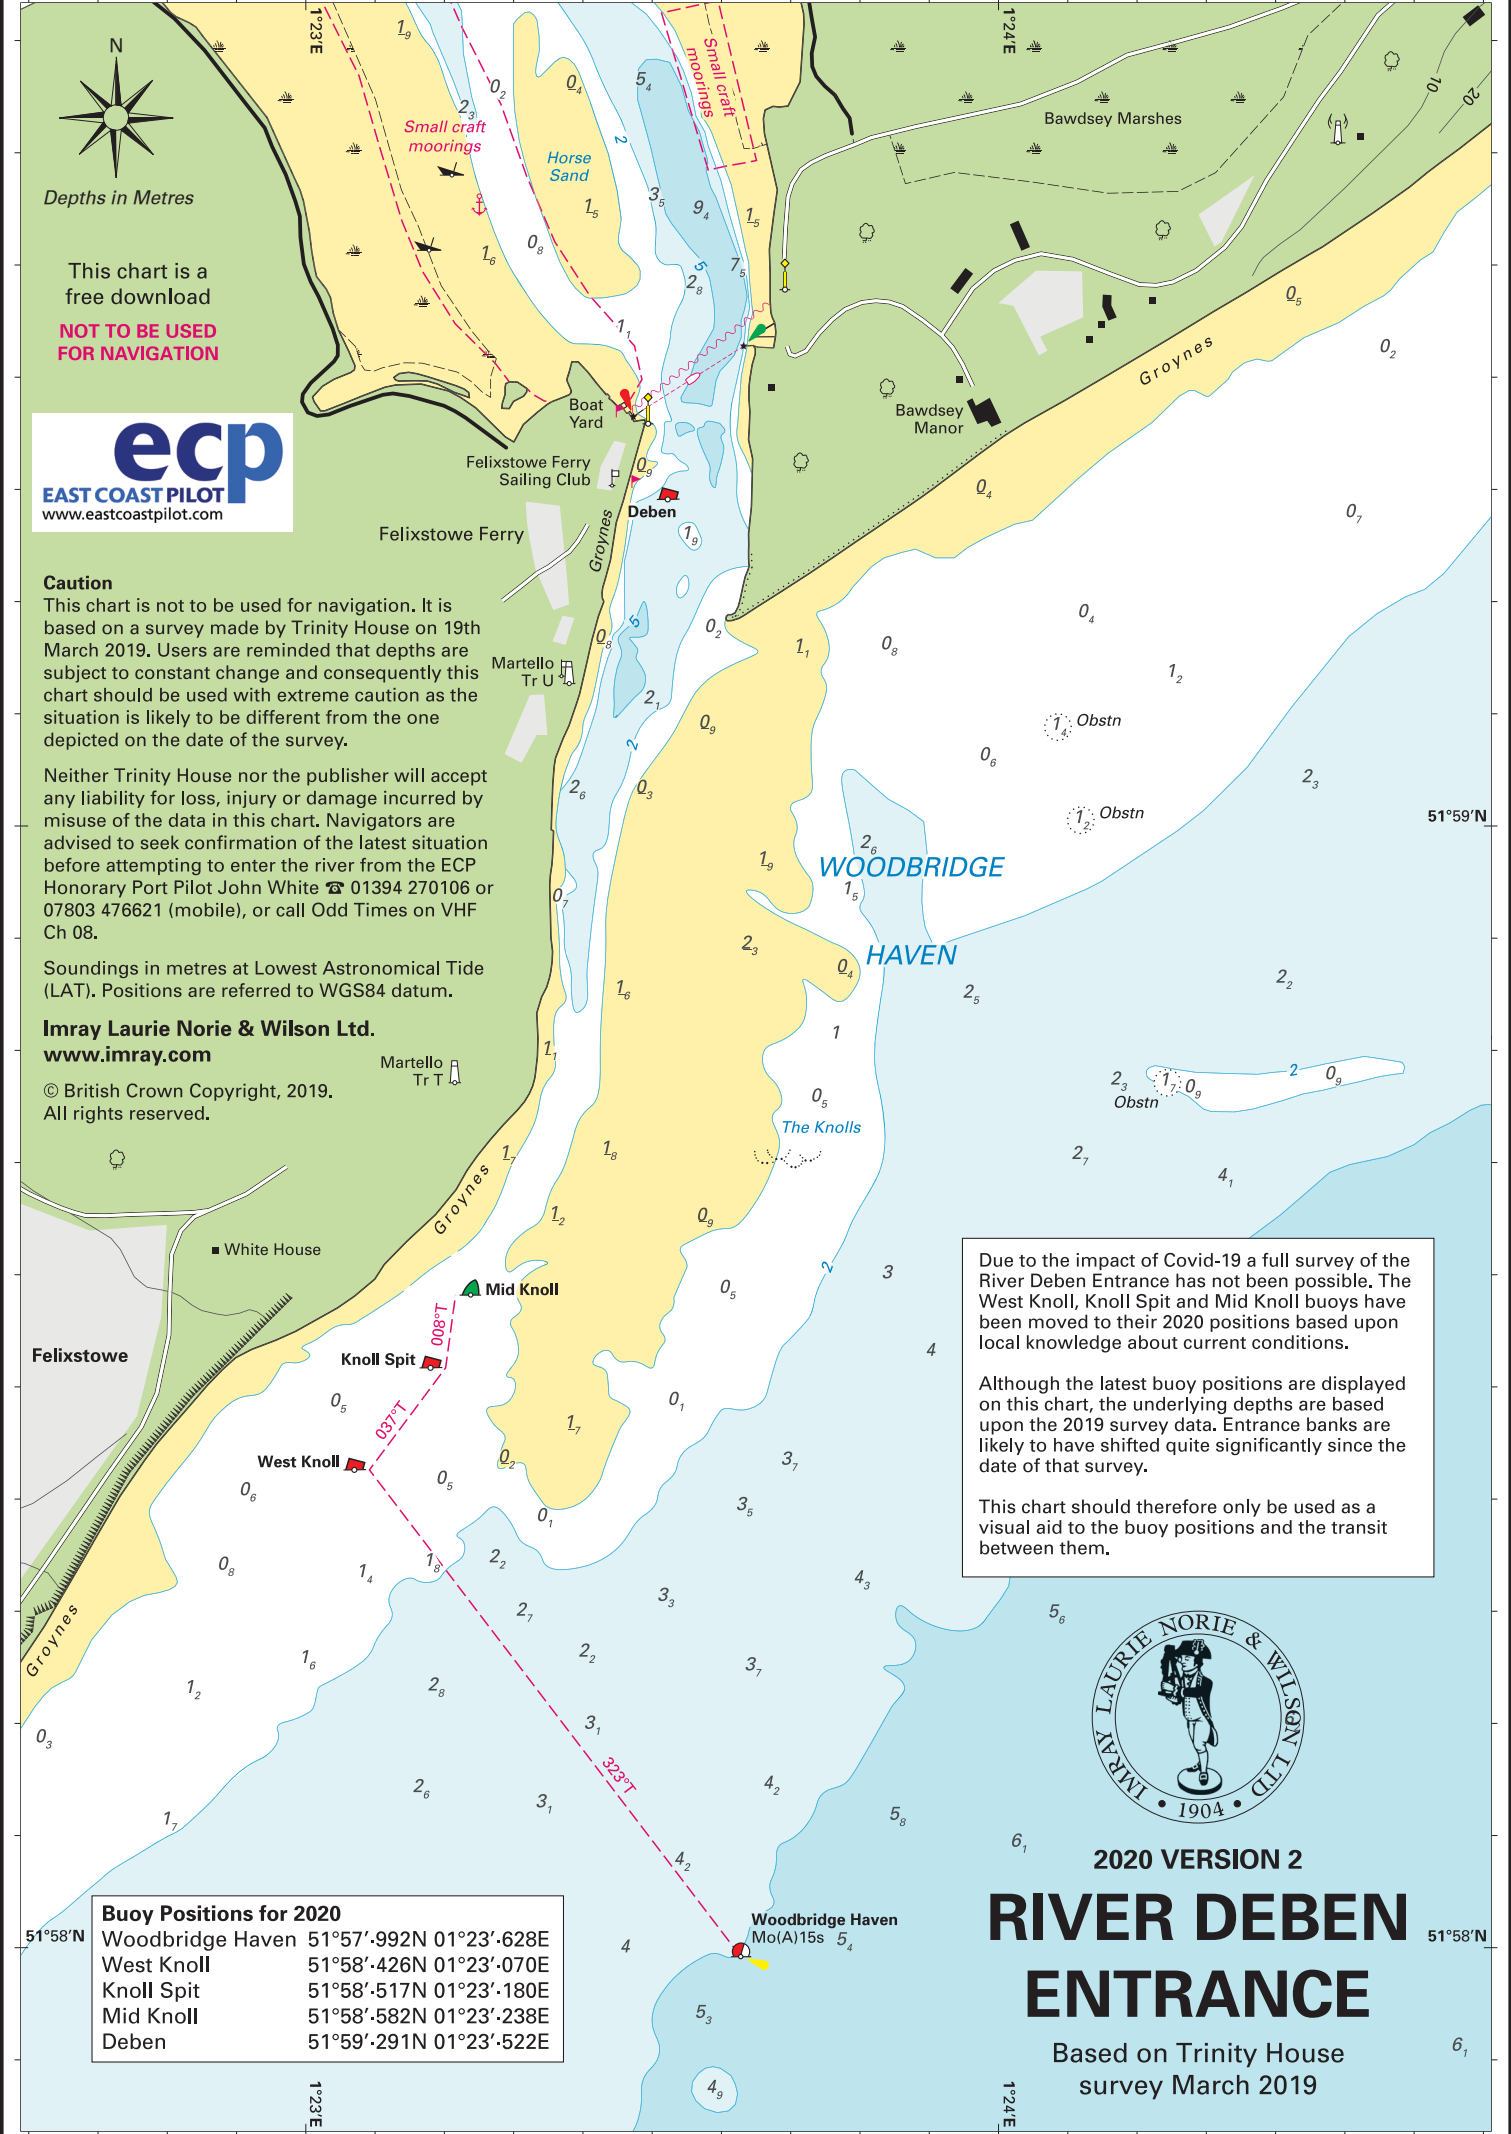
Soundings in metres at Lowest Astronomical Tide (LAT). Positions are referred to WGS84 datum.

Due to the impact of Covid-19 a full survey of the River Deben Entrance has not been possible. The West Knoll, Knoll Spit and Mid Knoll buoys have been moved to their 2020 positions based upon local knowledge about current conditions.

Although the latest buoy positions are displayed on this chart, the underlying depths are based upon the 2019 survey data. Entrance banks are likely to have shifted quite significantly since the date of that survey.

This chart should therefore only be used as a visual aid to the buoy positions and the transit between them.

Buoy Positions for 2020	
Woodbridge Haven	51°57'·992N 01°23'·628E
West Knoll	51°58'·426N 01°23'·070E
Knoll Spit	51°58'·517N 01°23'·180E
Mid Knoll	51°58'·582N 01°23'·238E
Deben	51°59'·291N 01°23'·522E

Imray's second 2020 chartlet for the Deben entrance follows on the next page of this PDF.

It was produced for us in July 2020, purely for illustration purposes to show the buoy positions in place at the moment.

*NO TRINITY HOUSE SURVEY HAS BEEN DONE SINCE MARCH 2019*, so the survey data remains unchanged from 2019 and must not be relied upon.
